Uffington Parish Council

REPORT ON FLOODING - WINTER 2023 / 2024, PART 2

ACTION PLAN

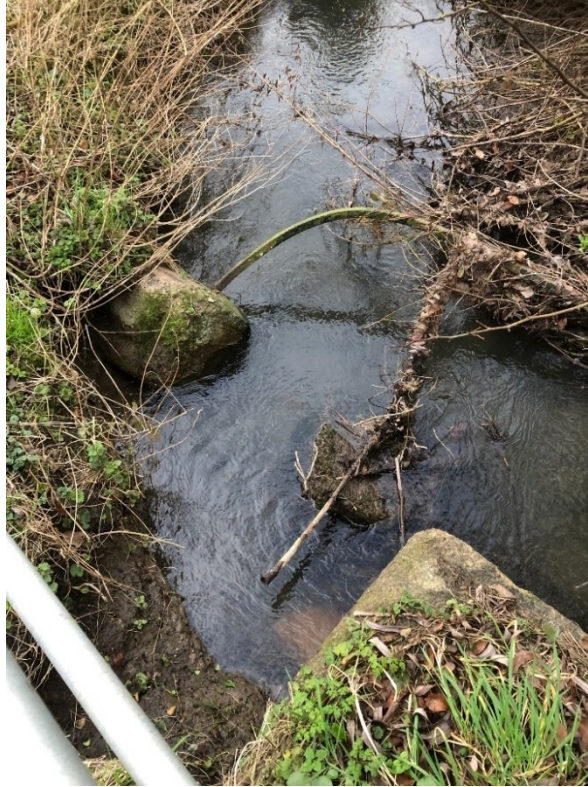
A section of guard rail embedded in a lump of concrete and part of the stream roadside wall fell into the Uffington Brook many years ago close to Uffington allotments and has been reported for repair several times on FixMyStreet. This partially blocks the stream, and the associated reduction in verge height allows flood water to back fill on to the road. The lumps of concrete should be removed and damage made good by OCC Highways, and the verge height reinstated. See photographs at Annex C.

Photo 1. Broken rail and lump of concrete in Uffington Brook, at allotments, Fernham Road

7	Many 'grips' are blocked, thus retaining water on the roads.	Re-institute annual maintenance / clearance.
	Fernham Road	
8	Obstruction and bank damage to Uffington Brook at Uffington allotments. Map: Point 3.	Remove obstructions and make good.
	Claypit Lane (from Longcot) and the road from Woolstone	
9	Culvert at 'Y' junction is partially blocked; capacity in doubt. Map: Point 4	Inspect and clear as required, and upgrade if capacity is insufficient.
10	Next culvert (20m downstream) is breaking down on both sides of the road. Map: Culvert entrance at Point 5	Inspect and repair as required; upgrade if capacity is insufficient.
	Broadway – from the south	
11	The pipe / drain from The Severalls at Shotover Corner to Garden Cottage (all on the east side of Broadway) is partially blocked or has insufficient capacity. Map: Entrance at Point 6	Inspect and clear as required; upgrade if capacity is insufficient.

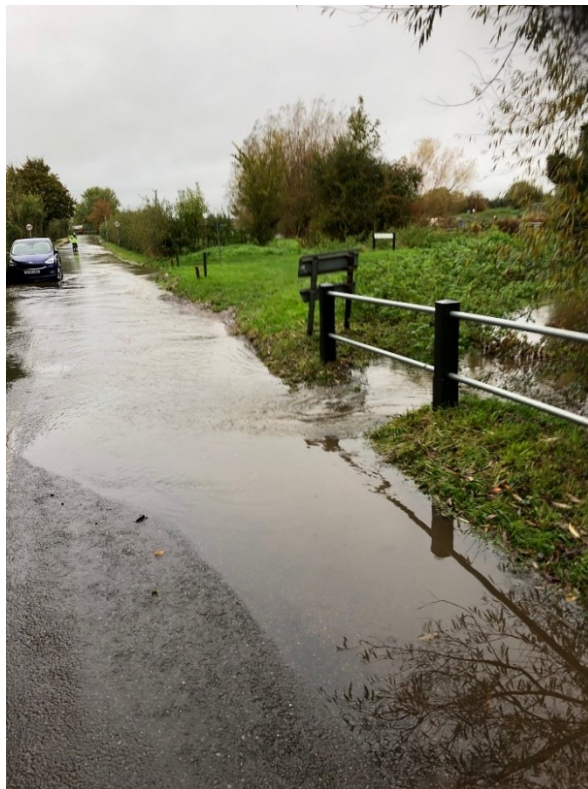
Photo 2. Damaged verge (at allotments) allows the stream to overflow onto the Fernham Road.

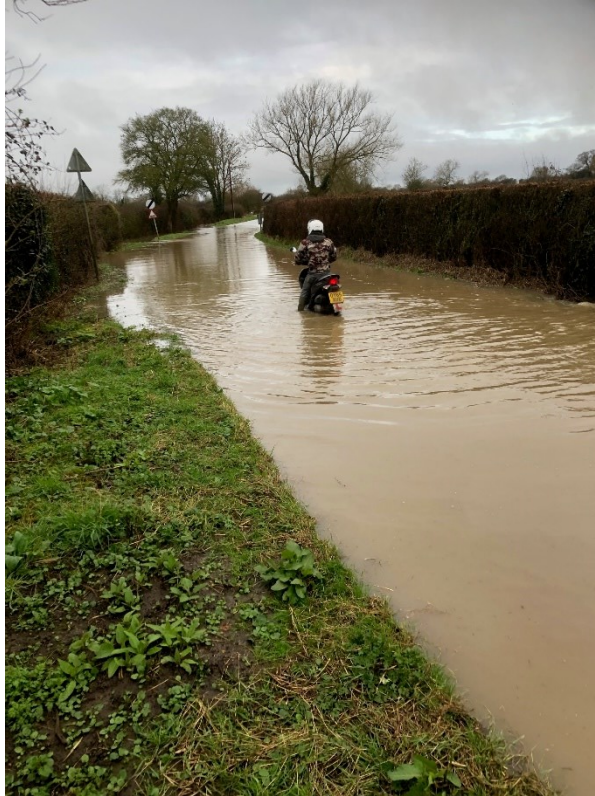
Flooding on the Woolstone Road, from the 'Y' junction with Claypit Lane to Bridge Cottage, is a regular occurrence. We believe this is because the culvert under the road (north to south) is either partially blocked or is not large enough. Initially, the culvert should be checked and cleared of rubbish and weeds, and upgraded if of inadequate capacity for current and anticipated future volumes of flood water.

Photo 3. The Woolstone Road, flooded again on 18 February 2024

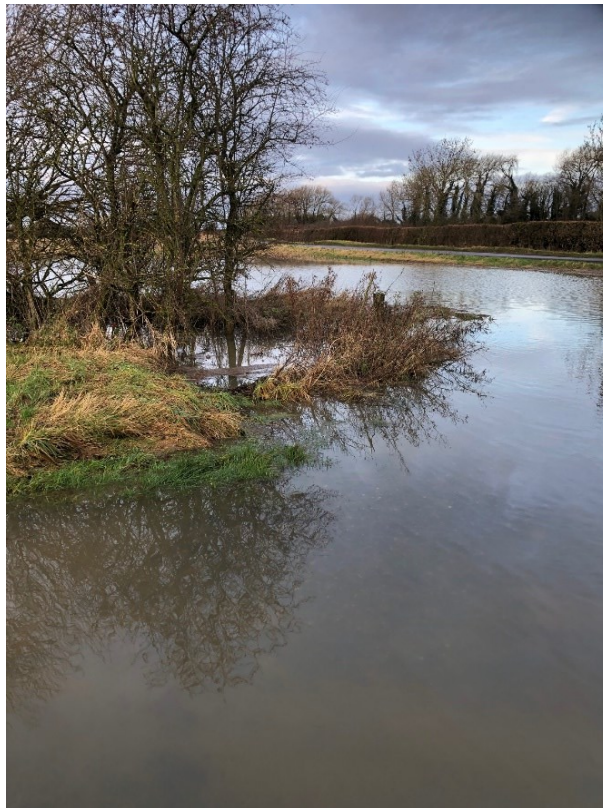
Photo 4. Flooding at the Claypit Lane / Woolstone Road 'Y' junction on 5 January 2024. (The entrance to the culvert under the road - north side to south - is in front of the tree).

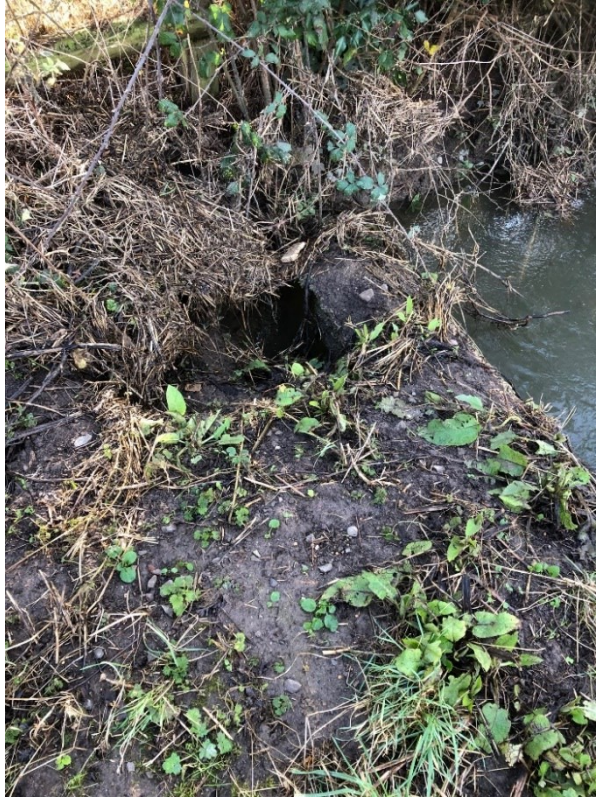
20 m downstream of this culvert, the stream crosses under the Woolstone Road again, from south to north. The entrance and exits to / from this culvert are breaking down, and will shortly increase the risk of flooding on the road. This has been reported to FixMyStreet. As above, the capacity should be upgraded if required.

Photo 5. The second culvert under Woolstone Road – south to north – is disintegrating, on both sides of the road.

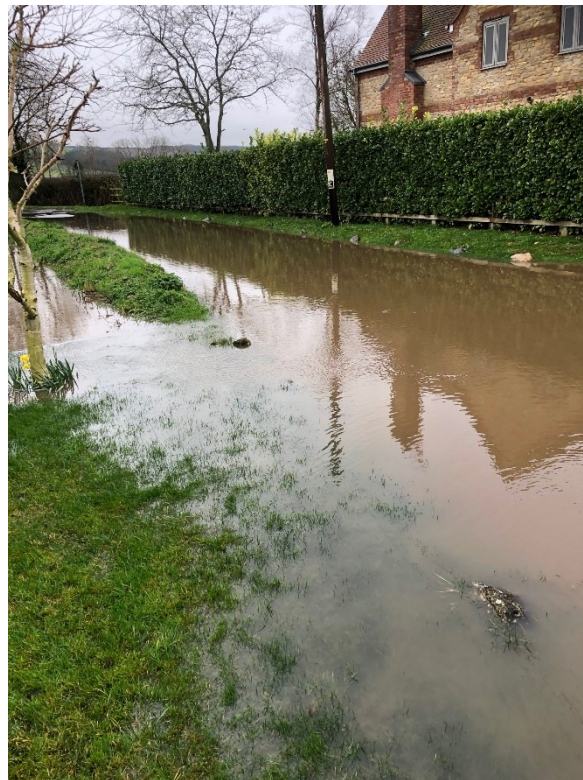
Flooding in the Shotover area, at the junction of Broadway and Woolstone Road, is a regular occurrence after a period of heavy rain. This was particularly severe during Storm Henk, when Shotover House was flooded – see above. Overnight 2/3 January 2024, flood water unable to get away from the culvert under Broadway and the closely adjoining culvert under the garden of Stonehaven, was flowing strongly on the road back towards the Broadway junction with Woolstone Road (Shotover) and westwards on Woolstone Road to Bridge Cottage, at a depth of more than 30 cm. The likely causes are:

Photo 6. Flooding at Shotover on 18 February 2024 (Stonehaven on the right), showing flood water back-filling on to the road, unable to get away, as below.

1. The pipe / drain under several access drives from The Severalls at Shotover Corner to Garden Cottage (all on the east side of Broadway) is partially blocked or has insufficient capacity. This should be checked, cleared, and upgraded if of inadequate capacity for current and anticipated future volumes of flood water.
2. The culvert under Broadway (east to west) and the adjoining culvert under the garden of Stonehaven is partially blocked or have insufficient capacity. Both should be checked for any blockage, cleared and upgraded if of inadequate capacity for current and anticipated future volumes of flood water.

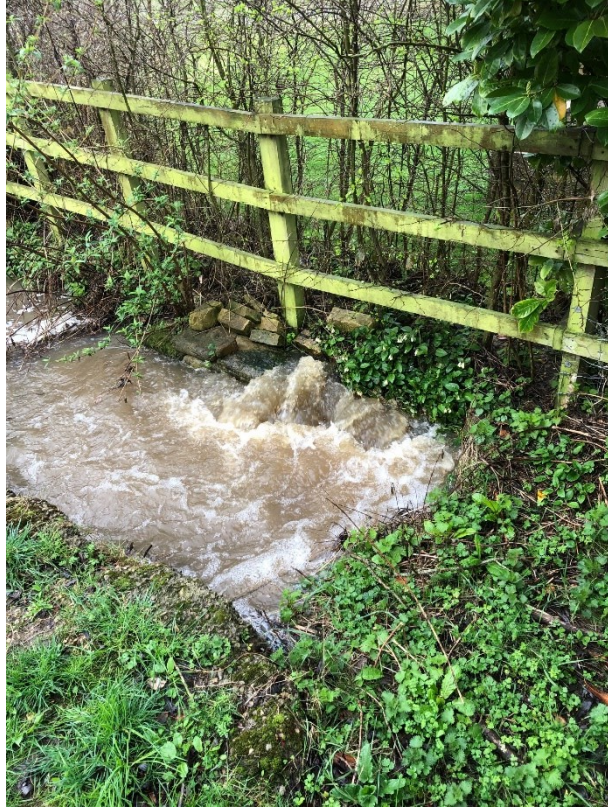
Photo 7. Entrance to the second culvert close to Stonehaven on 18 February 2024 – overloaded, and water unable to get away promptly.

12	The culvert under Broadway (east to west) and the next culvert under the garden of Stonehaven are partially blocked or have insufficient capacity. Map: Point 7	Inspect and clear as required, upgrade if capacity is insufficient.
	Fawler Road

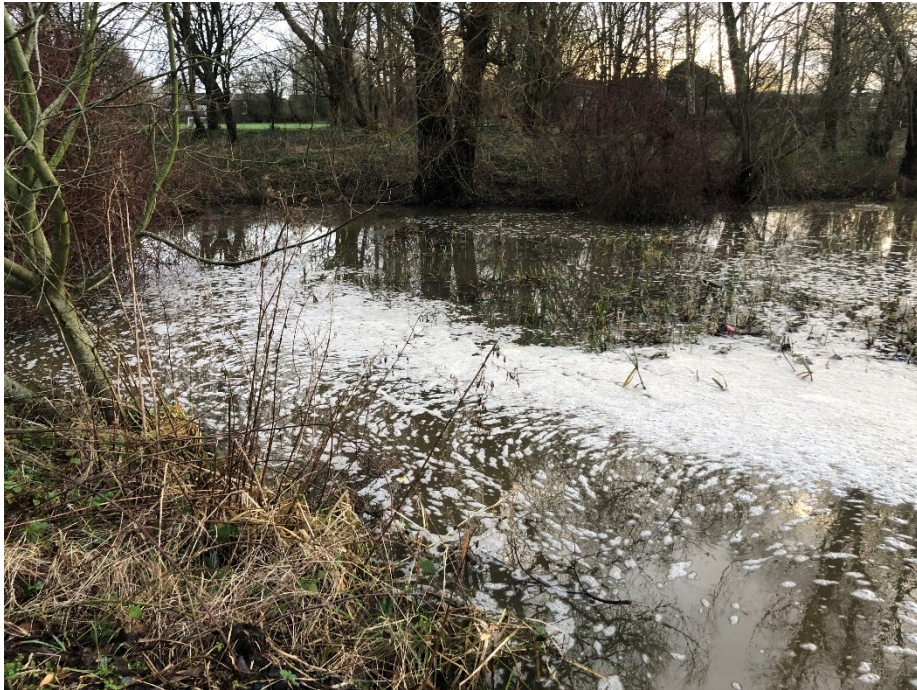
An unfortunate characteristic of much of the water circulating around Uffington, and particularly downstream of the STW, is sewage pollution. The extent of discharges of untreated sewage from Uffington STW is considerable, is monitored by Thames Water (TW) and is available on line. Instances of hydraulic flooding, usually in the lower sections of the village public sewage system, are reported by the Council to TW and the Environment Agency (EA). TW sometimes react quickly (e.g., to an operational blockage on the Woolstone Road on 4 February 2024), but the Council (and village as a whole) are very concerned that continuing and increasing pollution is now affecting previously clean parts of Uffington and populations of rare species such as water voles are increasingly at risk – or no longer visible. The EA is currently unable to supply testing kits for local usage by volunteers. See photos 8 and 9, at Annex C.

Photo 8. Pollution in Uffington Pond – 5 January 2024

This is a nation-wide problem involving most of the water companies. With regard to the Uffington STW, TW website indicates that they have a plan to improve the capacity to treat sewage, but information, openness, clarity and the timings are impossible to find. The Council urges TW to complete the planned works as a matter of urgency and to be more open and transparent with their customers.

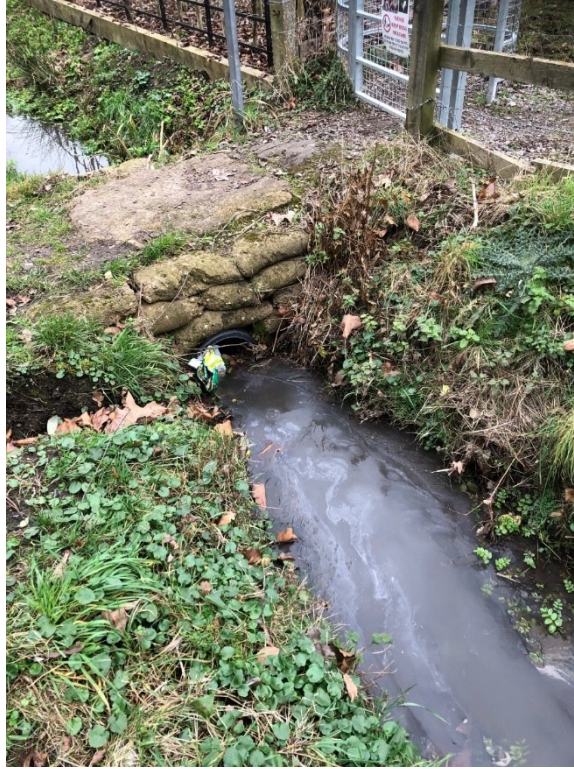
Photo 9. Pollution in the stream alongside Woolstone Road, at The Old Police House - 4 February 2024.

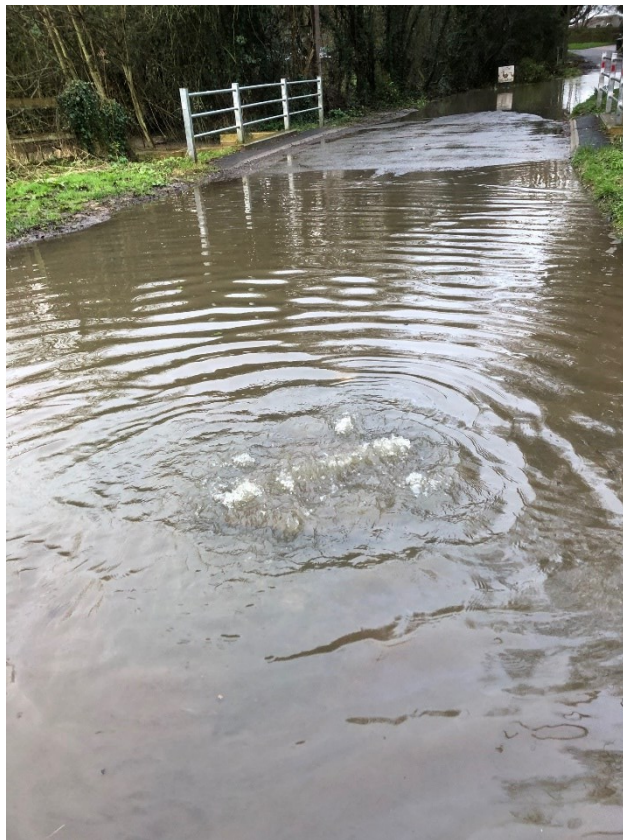
Photo 10. Hydraulic flooding from the main sewer, polluting the Uffington Brook outside Field House SN7 7RD on 18 February 2024.
